Navajo Abandoned Uranium Mine

Site Screen Report

South Portal, Frank No. 1 Mine AUM Site

March 2010

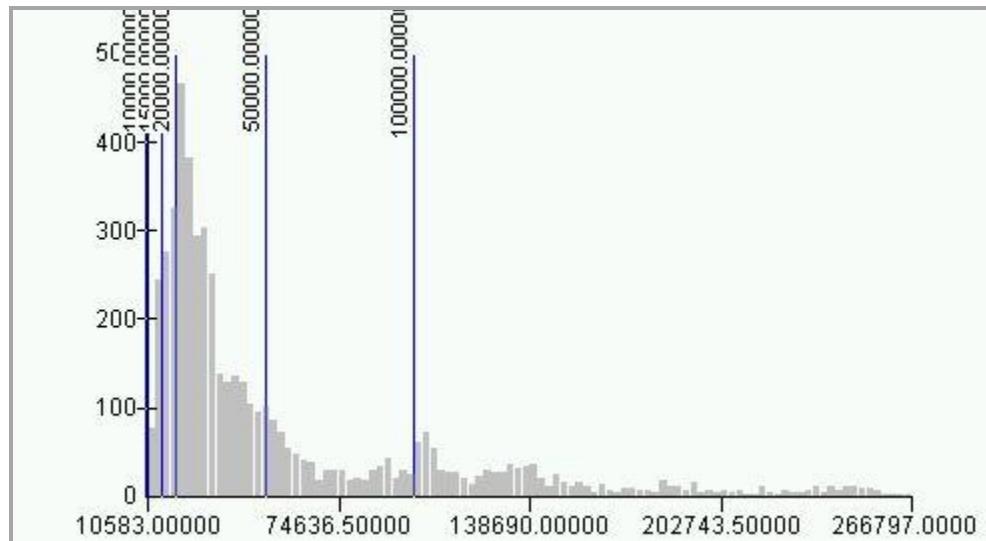
Distribution Chart and Statistics:

Count:	5076
Minimum:	10583.00000
Maximum:	266797.00000
Sum:	285861964.00000
Mean:	56316.38377
Median:	32767.50000
Standard Deviation:	51910.71907

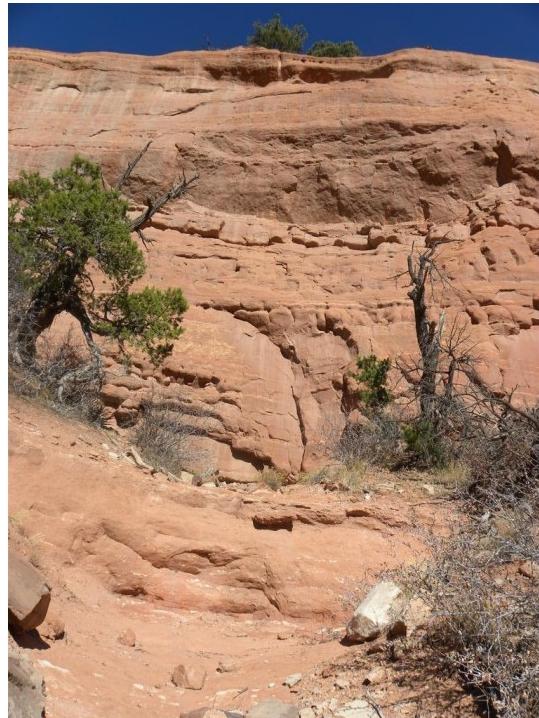
Photo 6. Cliff area

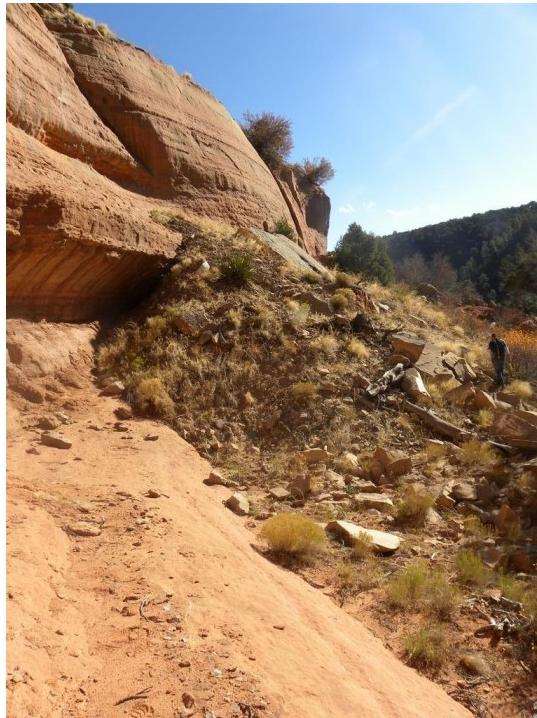
3 waste piles: two large 100' x 100', 50' x 50'; one of average size 25' x 25'; with a total estimated volume of 2,430 yd³

Photo 7. Large waste pile

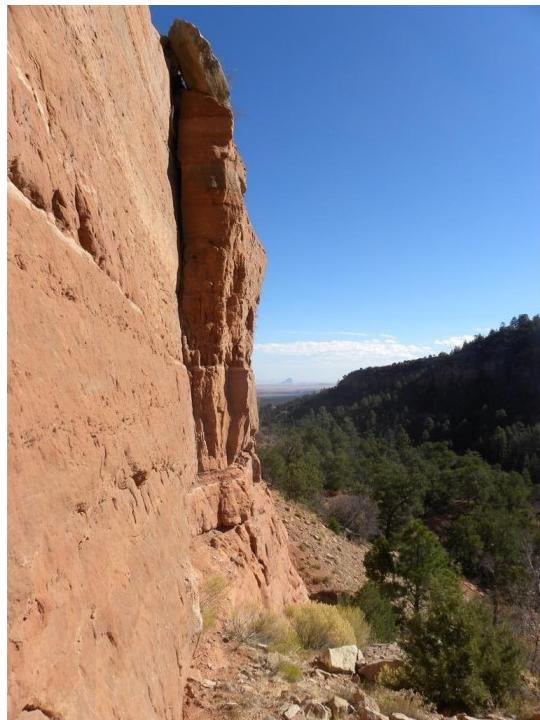
Photo 8. Waste pile

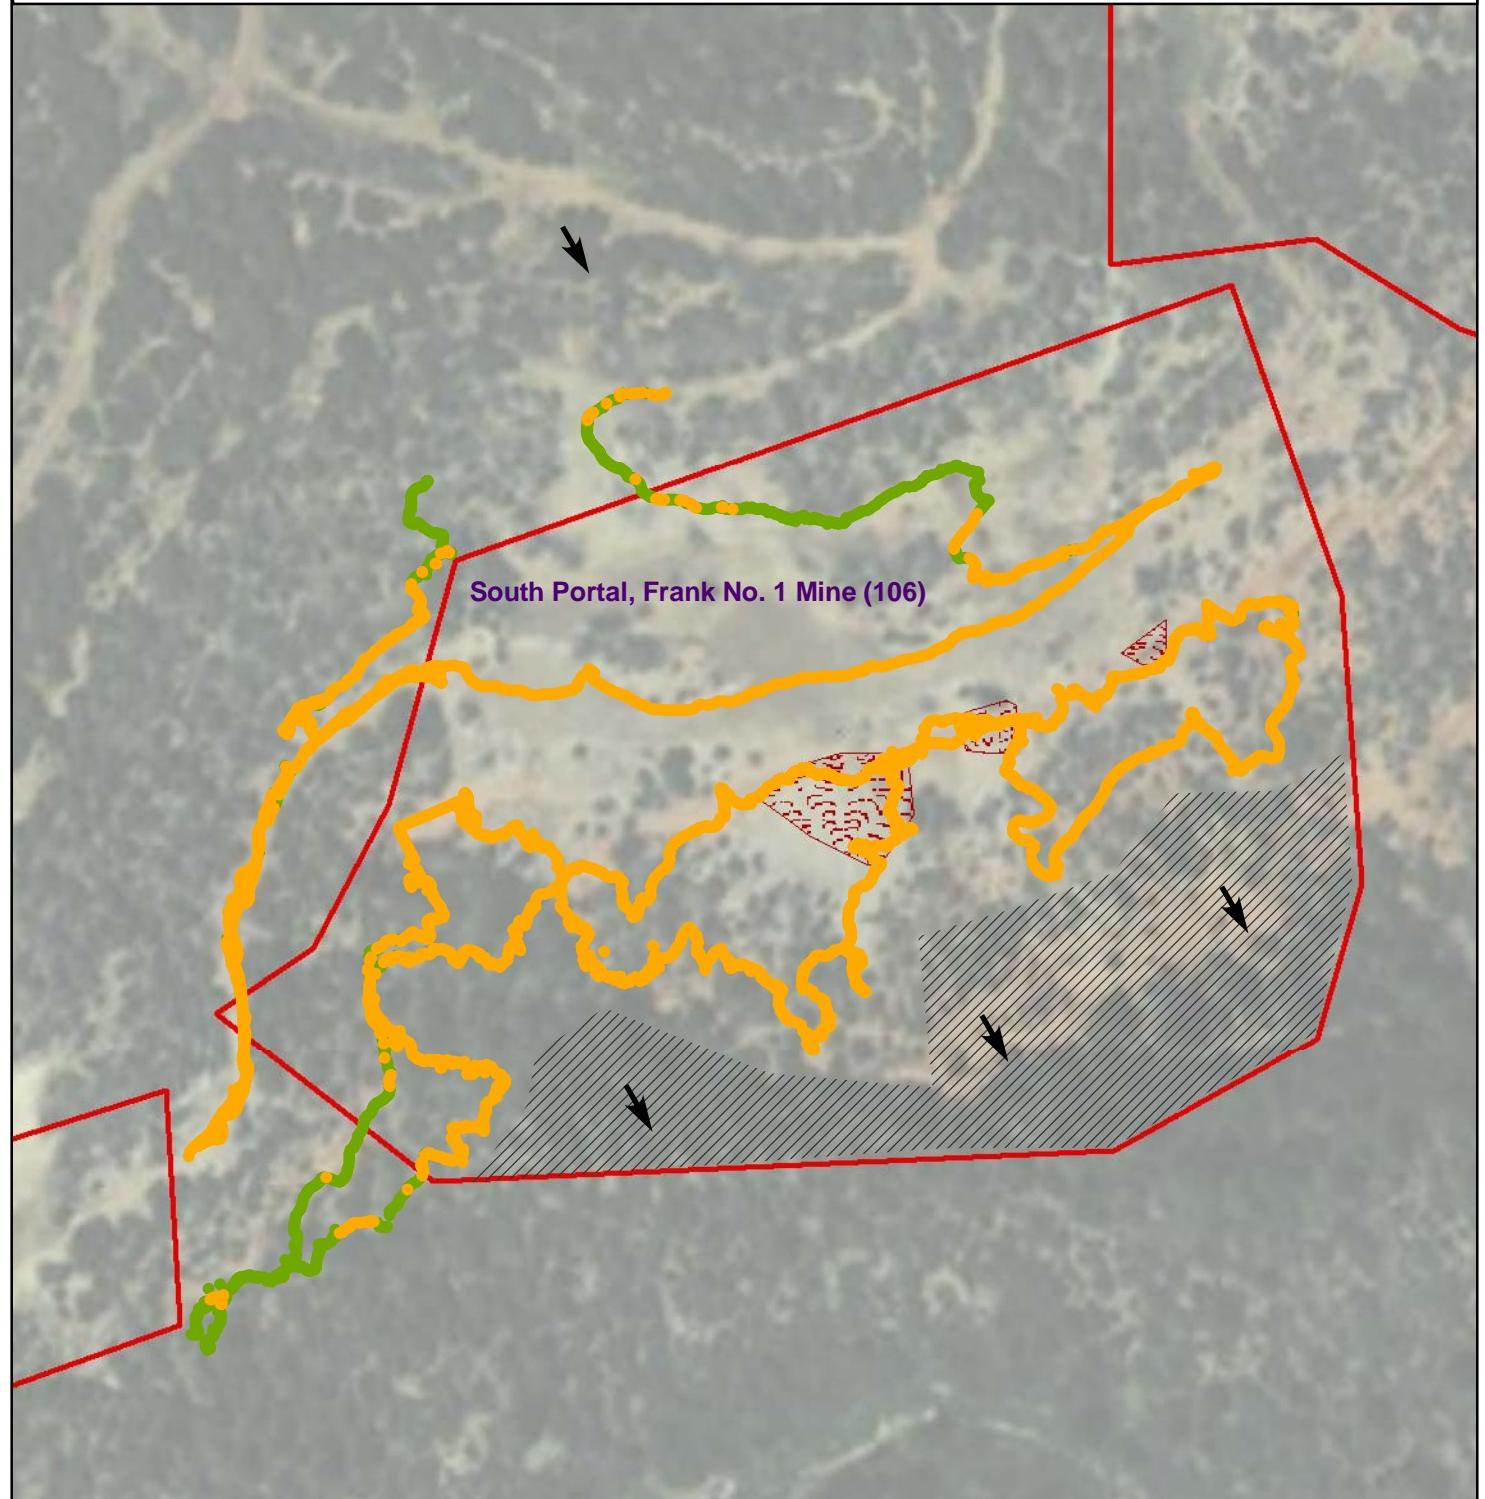
Figure 1 - Gamma Radiation Measurements, Above Two Times Background
South Portal, Frank No. 1 Mine (106)
Cove Chapter, Navajo Nation, Arizona

A total of 5,076 gamma radiation measurements were collected from the mine site, ranging from 10,583 cpm to 266,797 cpm. Measurements in the vicinity of the waste debris piles were found at levels of approximately 145,000 cpm, 70,000 cpm, and 175,000 cpm, and downstream of the piles at approximately 60,000 cpm. The measurements are represented in Figures 1 and 2.
